**MARYLAND HISTORICAL TRUST
DETERMINATION OF ELIGIBILITY FORM**

Property Name: Kurtz Farmhouse and Quonset Hut Inventory Number: WO560
Address: 4520 Market Street City: Snow Hill Zip Code: 21863
County: Worcester USGS Topographic Map: Snow Hill SE
Owner: Summerfield LLC. Is the property being evaluated a district? no yes
Tax Parcel Number: 20 Tax Map Number: 63 Tax Account ID Number: 02007630
Project: Summerfield Phase I Agency: Maryland Historical Trust
Site visit by MHT Staff: ☒ no ☐ yes Name: _____ Date: _____
Is the property located within a historic district? ☐ yes ☒ no

W0-560

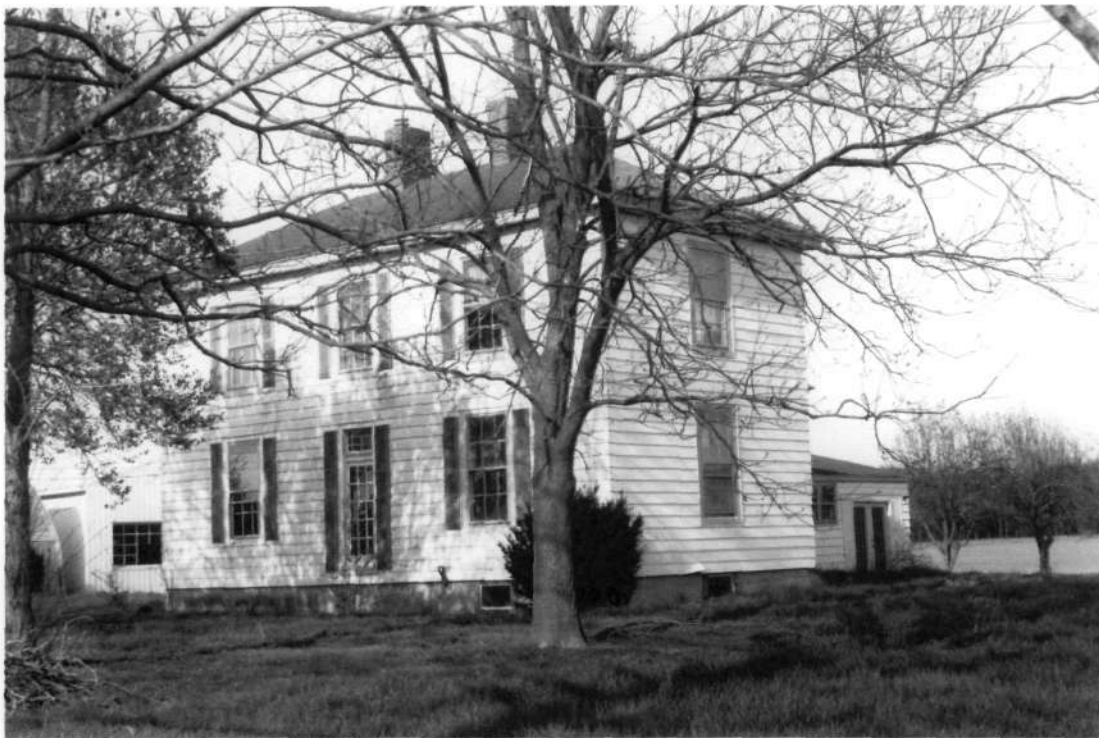
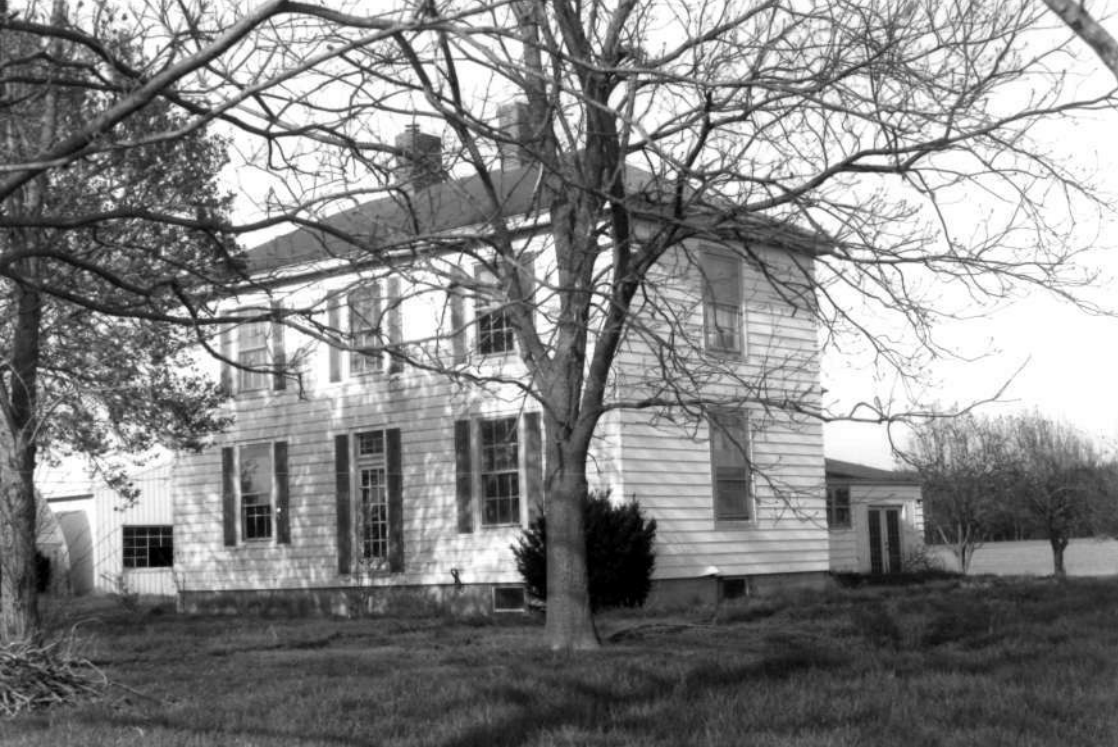
The Kurtz farmhouse was constructed during the mid- 19th century and features many original Greek Revival exterior and interior architectural elements. Numerous renovations and additions have affected the original layout and fabric of this residence.

This impressive west facing, 2-story, 3-bay farmhouse, has a L-shaped ground plan. The residence has a central hall floor plan and symmetrical fenestration. The façade is oriented parallel to the roof ridge and the low-pitch, asphalt shingled roof is penetrated by a paired interior ridge chimneys.

The wood, probably balloon frame residence rests upon a brick foundation covered with stucco. The house is sheathed with modern metal siding. The metal siding covers wood siding of an unknown style. Exterior details; include box cornices and wood sash, 6 over 6 light windows. Metal siding has obscured windowsills. The main entry is a 15 light wood door crowned with a 15 light transom and flanked by sidelights that have been obscured by metal siding.

Kurtz Farmhouse. View To Northeast.

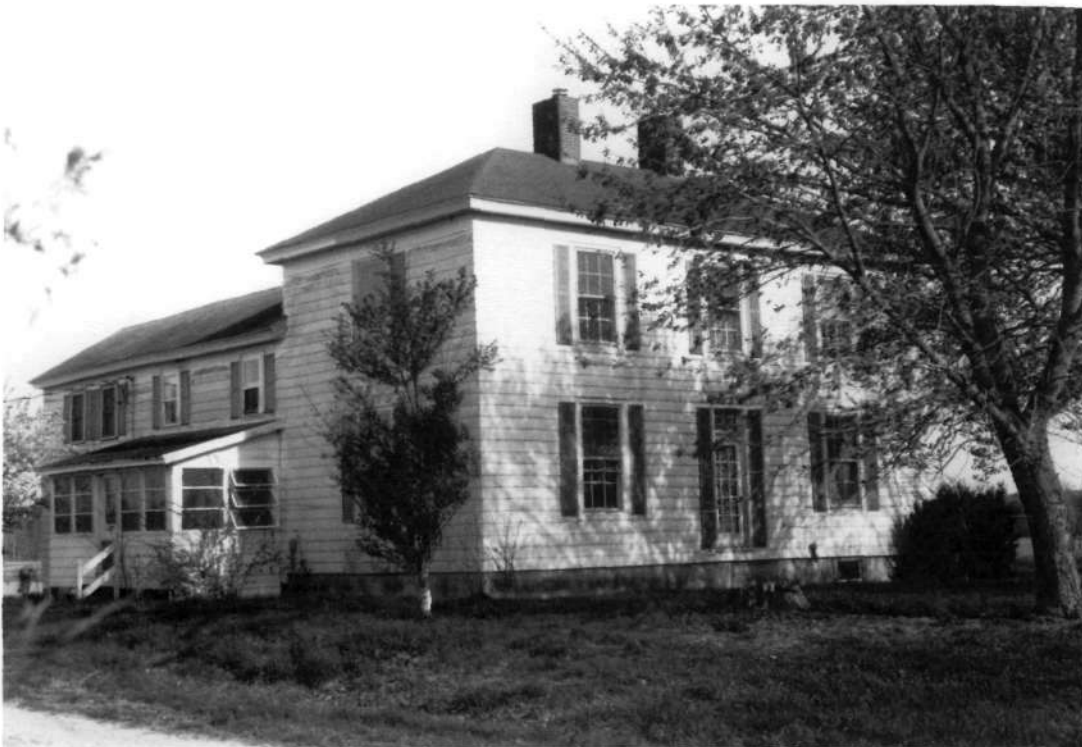
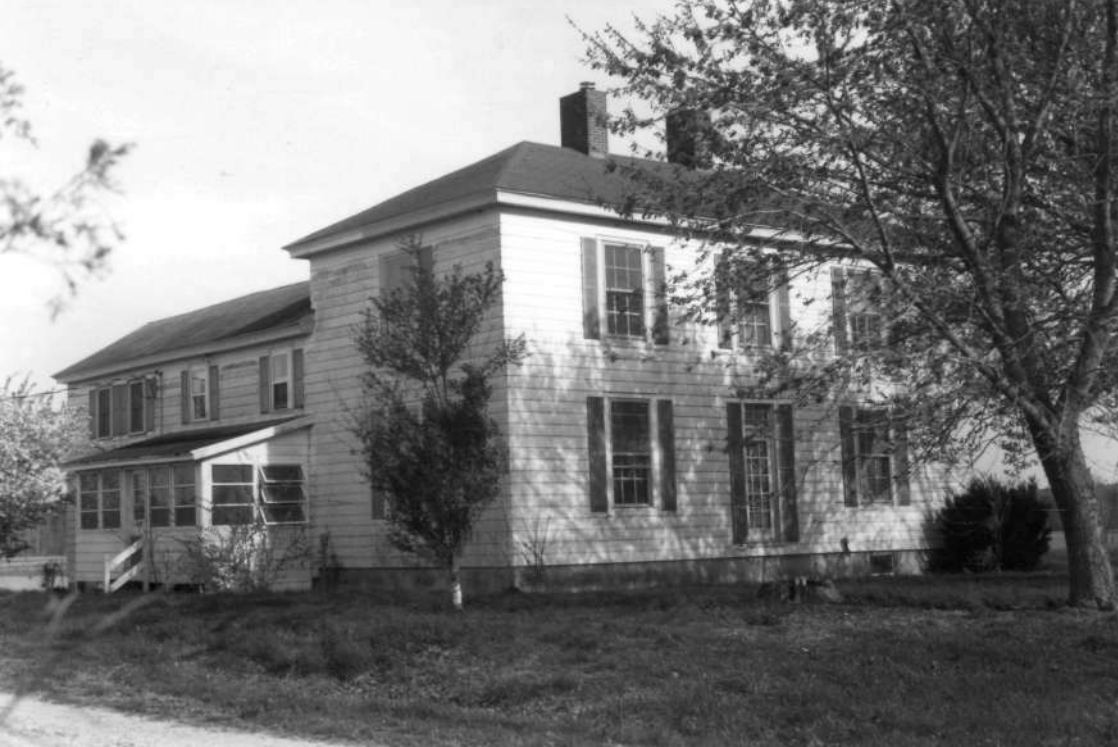
A rear addition has been built onto the left rear side of the main block of this house during an unknown period. This addition may have been constructed in 2 episodes or this addition may be 2 structures moved to this location at some time in the past. This 2-story, gable roof, probably wood, balloon frame addition rests upon a brick, concrete block and concrete slab foundation and features the same wall and roof sheathing materials as the main house block. Exterior details include, 6 over 6 and 1 over 1 light wood sash windows wood and metal doors.

A second addition has been constructed off of the right side of the rear addition. This single story, shed roof, probably wood, balloon frame addition rests upon a concrete slab foundation. This addition features the same wall and roof sheathing materials as the main house block. Exterior details include, 6 over 6 light wood sash windows.

Kurtz Farmhouse. View To Southeast.

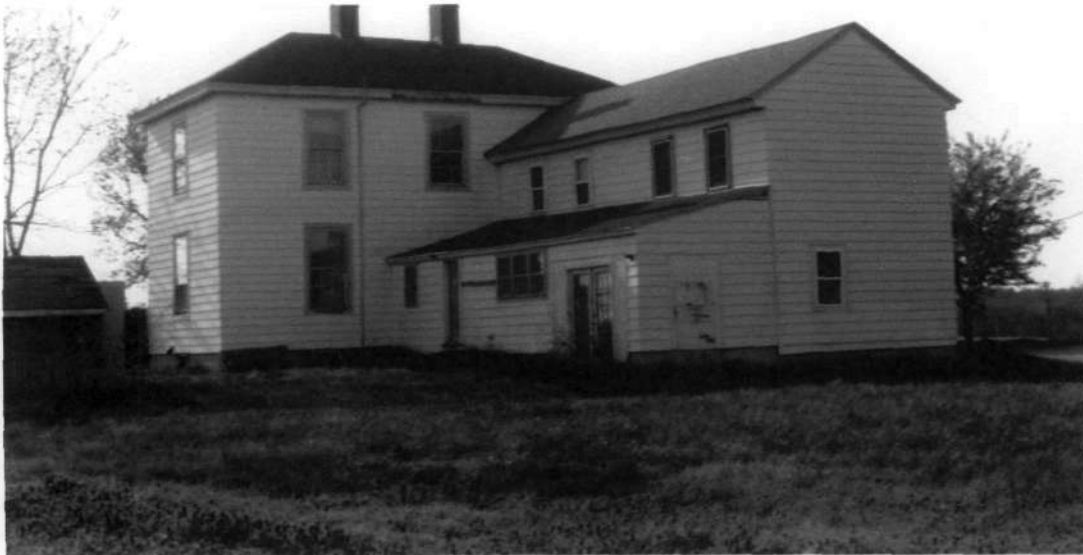
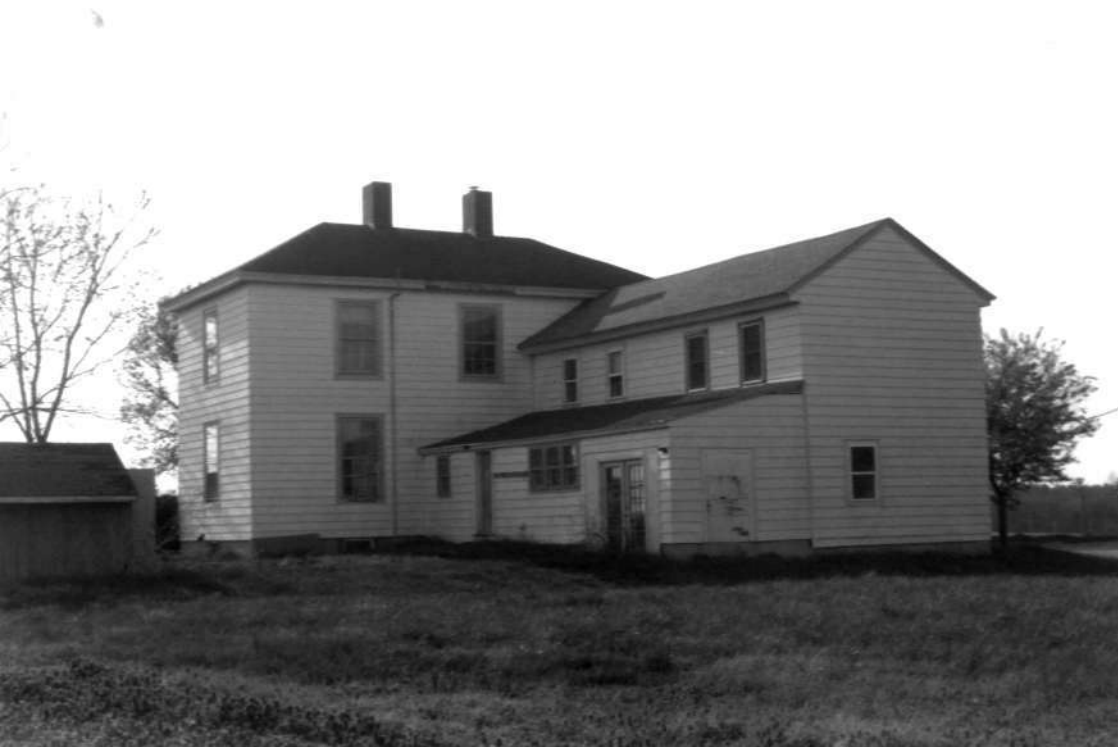
A modern shed roof, enclosed porch is located off of the left side of the left central addition. This porch is sheathed with metal siding, rests on a rockface concrete block foundation, has louvered windows and a central wood, 3 light doorway.

Kurtz Farmhouse. View To West.

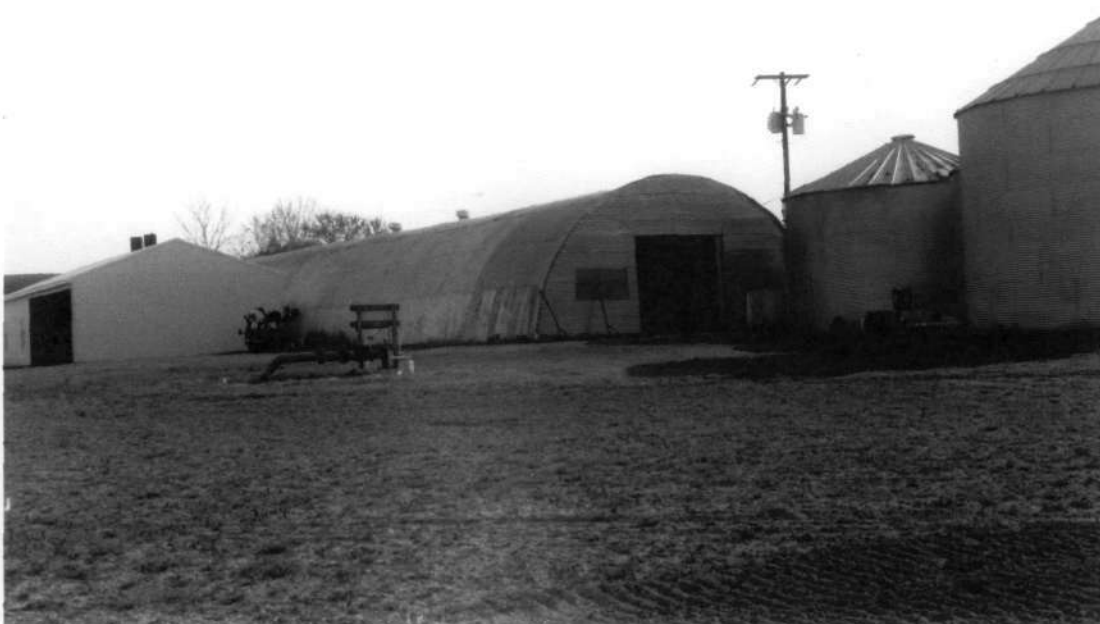
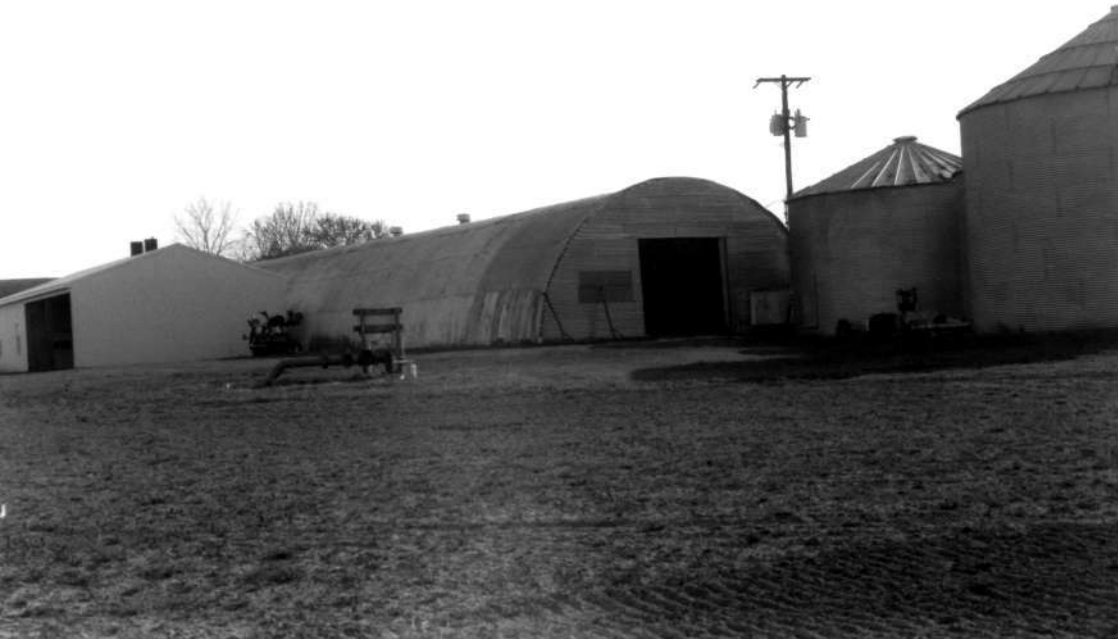
A 450-foot long, corrugated metal Quonset hut is located north of the Kurtz farmhouse. This Quonset hut rests upon at least 2 concrete slabs and is in disrepair. This structure is currently used to shelter farm equipment. The Quonset hut is recommended to be not eligible for NRHP inclusion under Criteria C due to failing condition and loss of setting.

Quonset Hut. View To South.
